Kentucky High School Athletic Association – Track & Field Site Inspection
Western Hills High School – Frankfort, Kentucky
 Site Inspection Requested by Julian Tackett, Assistant Commissioner of KHSAA
 Site Inspected by Gordon D. Boccock - #4848 – KHSAA Track and Field Consultant

Date of Inspection: April 25, 2008

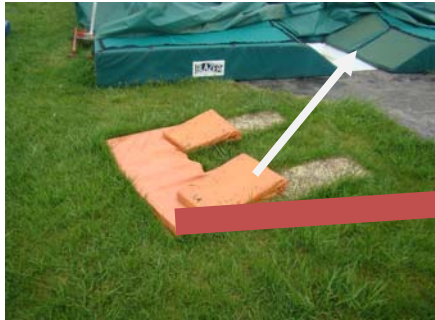
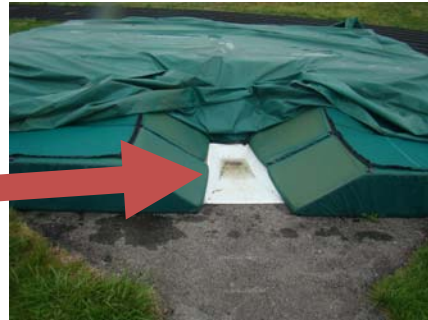
Western Hill Pole Vault Area of Concern

Western Hills has purchased a box collar but as the picture indicates it has not been properly placed in a position to help protect the athletes in a vaulting attempt.

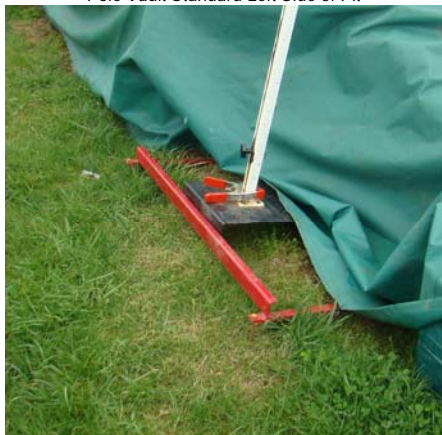
Pole Vault Standard Left Side of Pit

The ground in this area is not level and will cause the cross bar to be a different height on each side of the landing pad. Even though pegs are in place the standards are not secure to the ground as the raised pegs in the right picture indicate.

It is highly recommended that ground on both sides of the landing pad, from standard to standard be level and that concrete pads, the sides of the standard base be put in place so the standards can be secured for the season and removed at the end of the season so they pose no concerns for fall sports teams.

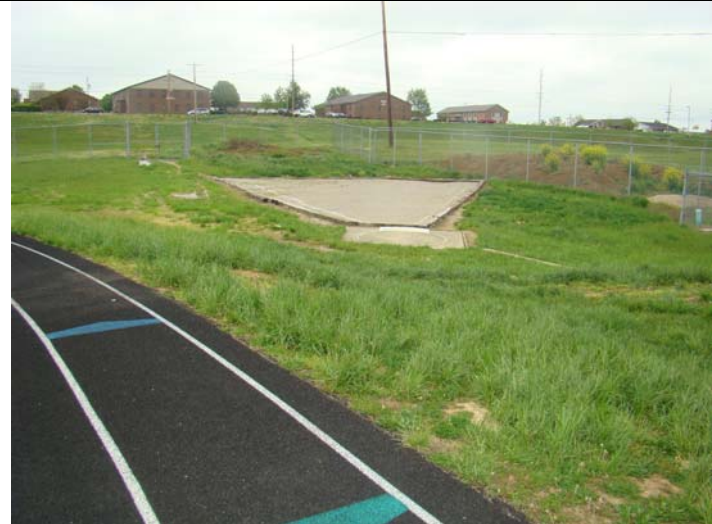
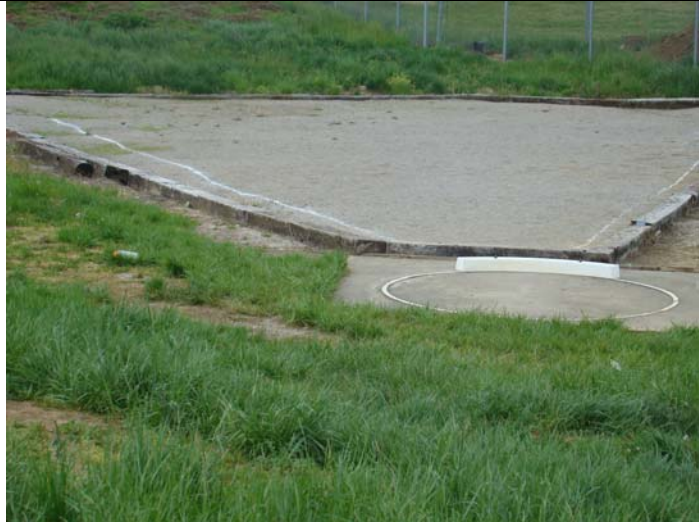
Venue #5 Shot Put

Circle - Concrete Pad	The pictures above give a pretty good indication of the shot put venue. Even though the area is greatly improved since the last site inspection this area is still very rough. As the picture indicates the circle and the sector are not plum the circle is the correct size, the toe board is improperly placed and no back half indicators or placed on the concrete slab. As the pictures show the concrete slab is not level.
Sector and Cage	The sector markings were put down for the 40 degree sector when they should now be 34.92 degrees. The sector or marking area is 100 percent better than it was at the first inspection. No cage is required at this time, but since this venue is in a highly traveled area thought might well be given to putting one in place.
Weight in of Implements	It is pointed out that the <u>host school is responsible</u> to provide scales for the KHSAA Meet Official to weigh all the throwing implements before each competition. It is <u>highly recommended</u> that each coach weigh his or her athletes implements weekly to assure that they are legal and that no alterations have been made to the implements.

Surrounding Area	The venue is just past the common start and finish line and flagging may well be needed to be a warning to wandering athletes and spectators that they are approaching a throwing area. With the way the total area is tilted to the right causes the concern of how safe the circle would be on wet days as the water drains and stands in this area.

Shot Put Venue (General Notes)	Even though the shot put area has received a lot of attention it is still not a good throwing area. The concrete circle should be level, and the toe board should be moved that the center of the toe board is directly down the center of the sector. Care should be given to marking the proper 34.92 degree sector so the athletes in this event will know there boundary lines. Concerned with the area on wet days.
-----------------------------------	--

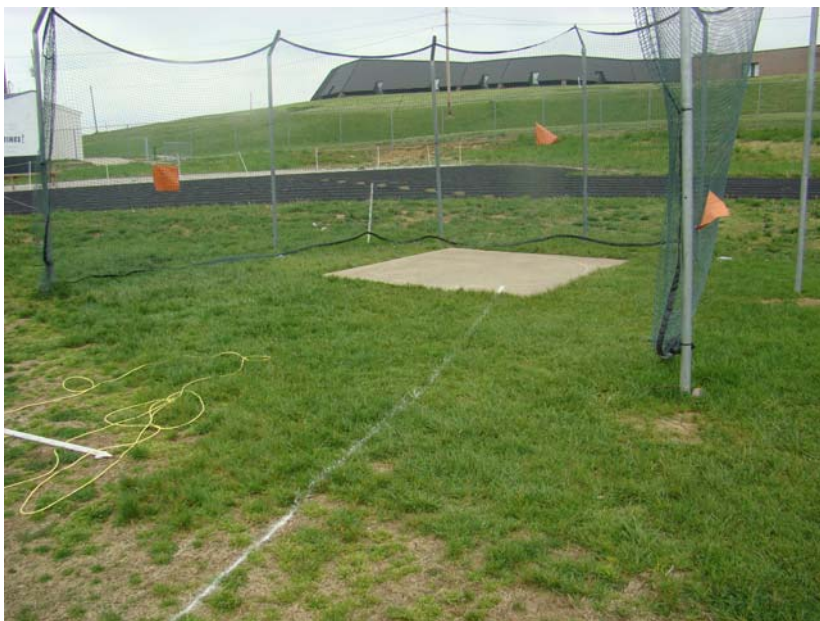
Circle – Concrete Pad

The concrete slab is 10' x 10' and is in good condition. The metal ring is almost invisible, as the picture above indicates. The ring needs to have the rust removed and a fresh coat of paint. The back half indicators are not present on the concrete slab.
Sector and Cage	The sectors lines were incorrect as they were at a 40 degree sector when they are now at a 34.92 degree sector. The cage is not properly in place. The front poles of a cage are to be within 5' of the sector lines.
Weight in of Implements	It is pointed out that the host school is responsible to provide scales for the KHSAA Meet Official to weigh all the throwing implements before each competition. It is highly recommended that each coach weigh his or her athletes implements weekly to assure that they are legal and that no alterations have been made to the implements.
Surrounding Area	As the picture shows a stake and rope it is evident that this area has been roped off and it should continue to be roped in practice and in meets.

Discus Venue (General Notes)	To correct the correct placement of the cage that, when standing in the circle, the left front pole remain in the same spot. The left sector line then be placed on the ground 4' to 5' from the edge of that pole. The right sector line should then be placed at the 34.92 degree sector and then the right front pole be moved in so that it is 4' to 5' from the sector line. This will move the center of the discus landing sector more to the center of the field and have the right side out of rounds further away from the running track.

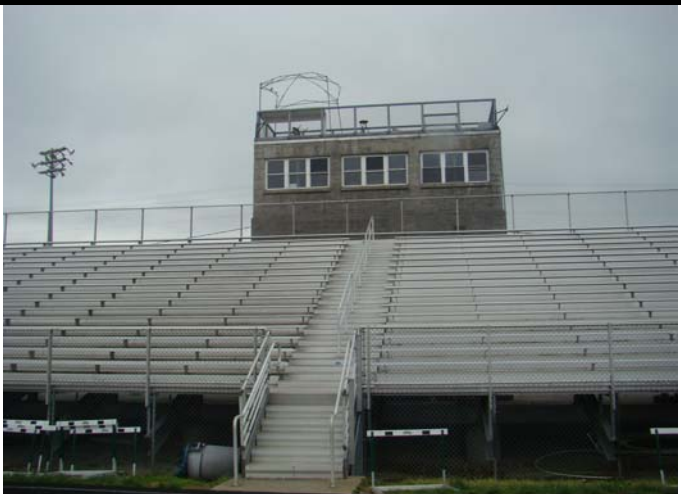
Seating and Spectator Control	<p>Seating is more than adequate for a track and field competition. Some crowd control needs to be put in place at both ends of the bleachers to assure that the spectators are safe at all times form the competing athletes as well as throwing implements. Steps to and from the bleachers should be controlled by Track Marshals to assure that no one wanders out to the track during a competition.</p> <p>All track events can be viewed very well from the bleachers and every effort to keep spectators in this area should be put in place to assure the safety of all.</p>
