Kentucky High School Athletic Association – Track & Field Site Inspection

Davie County High School – Owensboro, Kentucky

Date of Inspection: Wednesday, March 26, 2008

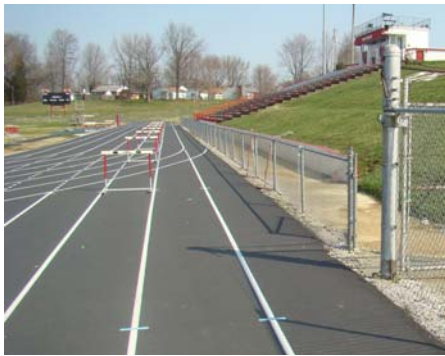
Picture #1 . . . shows the 8 lane finish straightaway

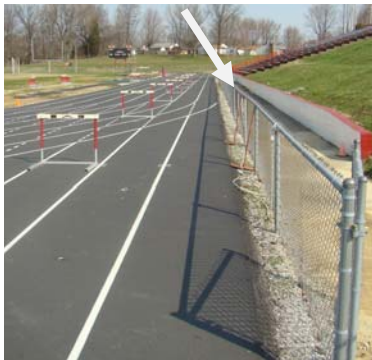
Picture #2 . . . shows the closeness of the fence to the athletes in lane 8, especially hurdlers with bad technique. Recommend capping this fence and the one on the backstretch and curve as well.

| Surrounding area (This could include bleachers, fencing, trees, limbs, etc.) | Crowd control is excellent around the entire oval. The only problem observed with the fencing is that located on the straight away is extremely close to lane 8 and could prevent some safety concerns with young people hurdling in the outside lane, especially those with bad hurdling technique and improper arm action. The capping that is used on outfield fences in baseball/softball is recommended to be used in all hurdling areas if lane 8 is to be used. Bleachers on both sides of the track are more than adequate for track and field competitions. Athletes exiting the track during or after competition have some safety concerns. (see pictures) |

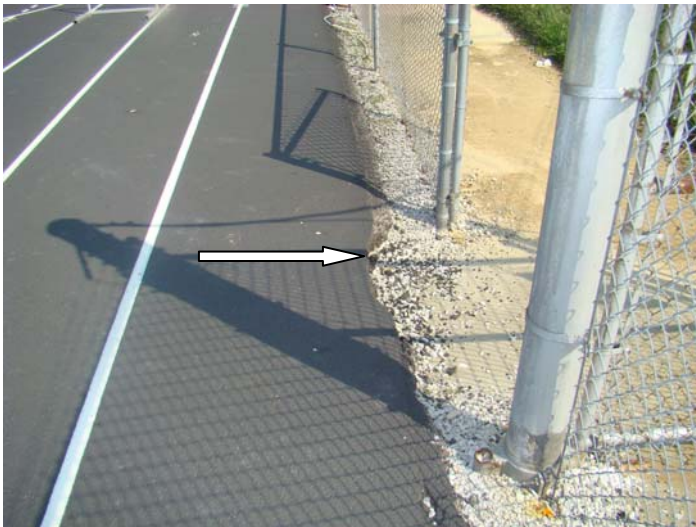
Picture #4 . . . shows the outside edges of the track that have having chunks to disappear.

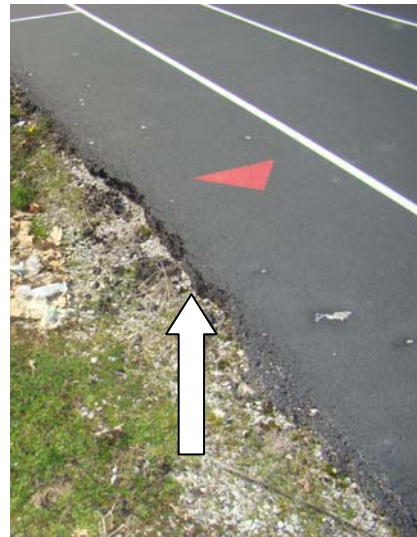
Picture #5 . . . show lane 8 with the edges of the track falling apart.

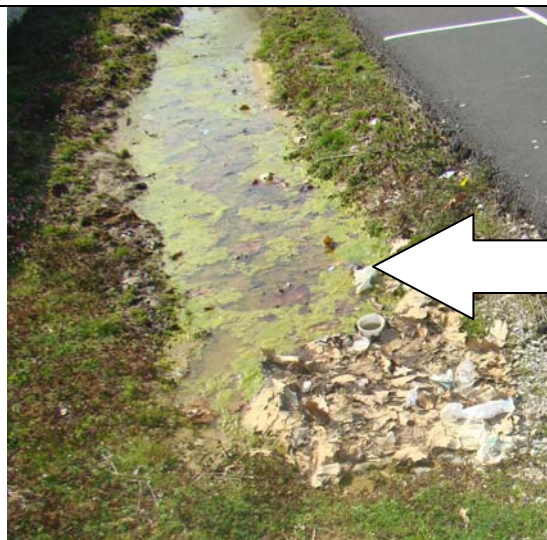
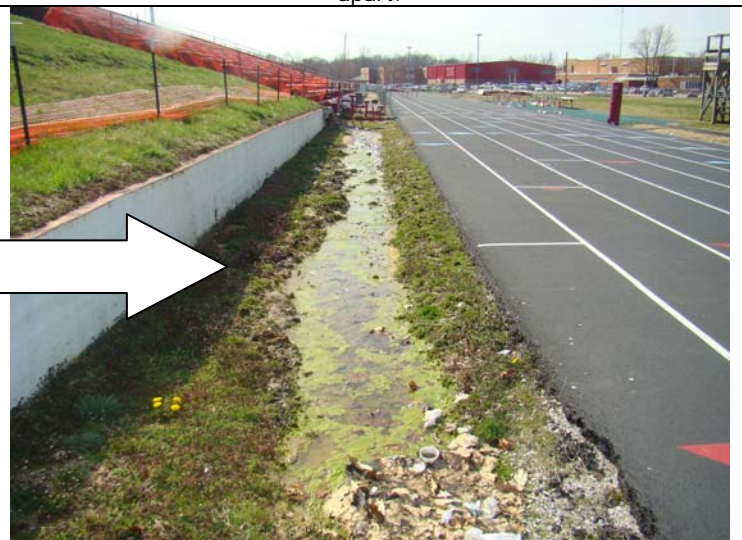
Picture #6 and Picture #7 may well be more of a Health Issue but safety issues could well come into play if a falling athlete were to land in the Daviess County Swam

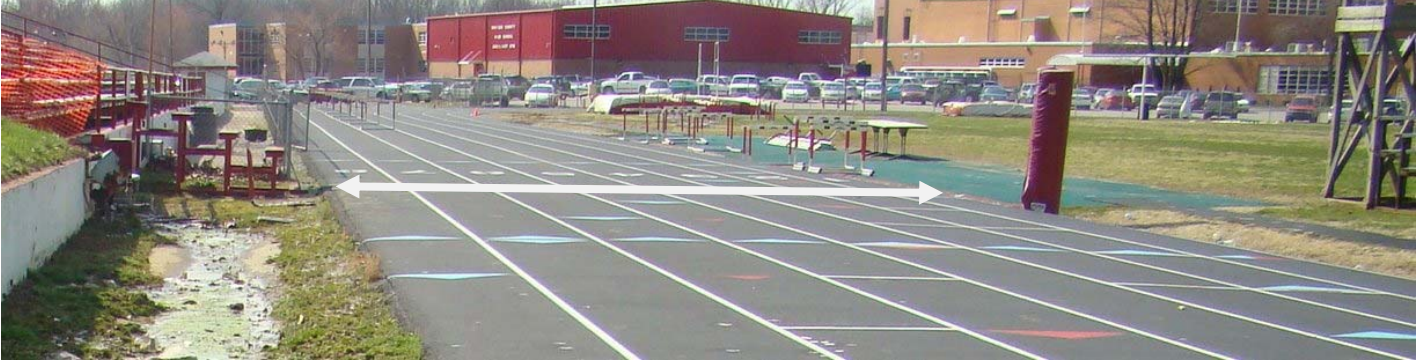
Picture #8 . . . Shows the Daviess County Swamp in relation to the finish line. It also shows the Maroon Monster that houses the finish line electrical supply. Although well padded. To the right is the drainage ditch and the long ump area. Where do athletes safely go when exiting the track?

| Finish Line Safety | Finish line safety may well present some safety issues . . . Electrical post - to the left and just past the finish line (although well padded) is a concern for athletes finishing that must exit the track. Edges of running surfaces at the finish area are a concern (see pictures) The swamp just off the track to the right (see picture) is very much a safety concern and quite possibly a health issue for the young people that are exposed to it. |

| Regional Meet Site In your opinion would you recommend this facility to be considered as a Regional Track and Field Meet Site? | If the Regional Meet was to be held in April we could not recommend that the meet be held at Daviess County the following items need to be addressed for the KHSAA to recommend a Regional Track and Field Meet at Daviess County High School. Pole Vault issues pertaining to exposed pallets and box collar. High Jump issues pertaining to hard and unyielding surfaces, exposed pallets and a very unstable take off area. Shot Put issues pertaining to ability to keep the circle dry and clean. Discus issues pertaining to ability to keep the circle dry and clean. Long and Triple Jump pits need a complete overhaul the pits and runways need immediate attention. They are completely unsafe at this time. Finish Line issues need to be addressed for safety concerns (electrical post, the swamp between the track and spectator area) |

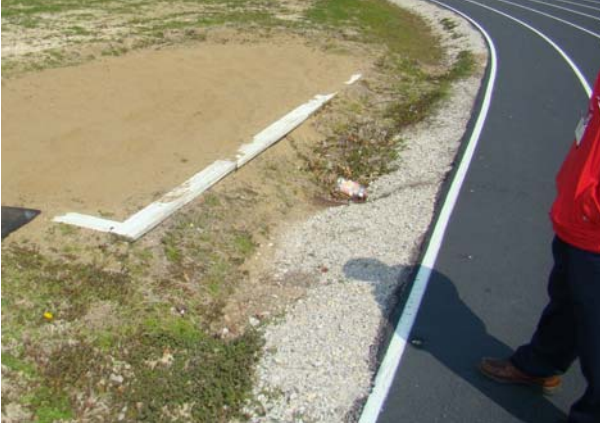
Picture #9 to the left shows the condition of the area where the distance runners and relay runners must step off the track after competition to allow lapped and other athletes to go by. Not sure footing at best.

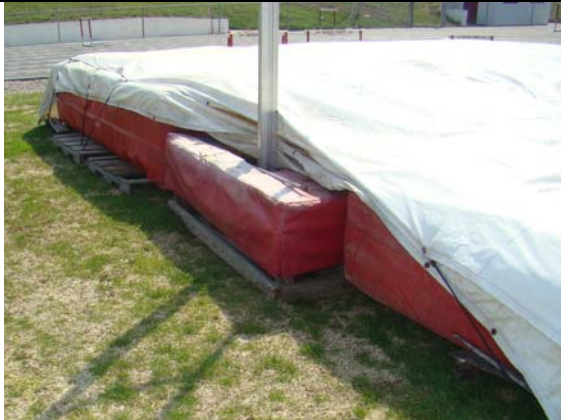
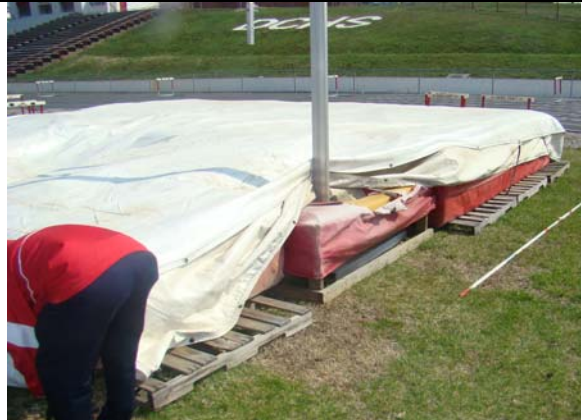
| Area surrounding the Pole Vault Venue | The area around the vaulting venue is fine as all the hard and unyielding surfaces are covered. It is pointed out that the pallets under the landing pads need to be constantly observed as the constant movement of the pads during the athlete's landings causing the pads and/or pallets to move and sometimes the pallets become exposed causing hard and unyielding surfaces. This can be a major liability issue. |

Pictures #10 and # 11 . . . Pallets are great for keeping the air circulating and add life to the vaulting pits, but are very much a safety issue when they become exposed. They are very much a hard and unyielding surface that must be covered in both practice and competition.

| Pole Vault Venue (General Notes) | Before the Daviess County vaulting venue can be cleared for Regional competition the box collar needs to be in place and the pallets that protrude from under the pit must be covered or secured in such a way that they do not move out from under the pit. |

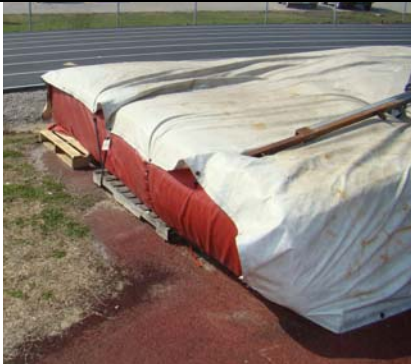
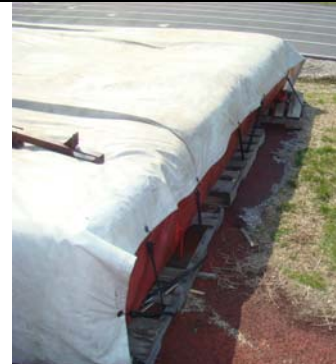
Pictures #12 and #13 show the problem with the pallets as well as the hard and unyielding surface that is exposed. Both the pallets and the hard and unyielding surface should be covered in both practice and competition.

| High Jump Venue (General Notes) | The issues with the hard and unyielding surfaces and the exposed pallets should be addressed immediately before anymore competition and/or practice takes place. Once the safety issues around the pit are addressed the very poor condition of the High Jump Apron needs some attention, especially at the point of take off for the athletes. |

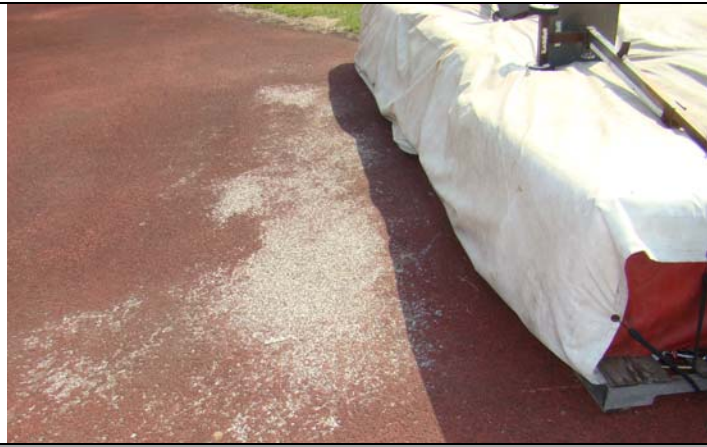
| HJ Apron | The high jump apron is more than adequate to meet the needs to assure enough room for the approach for all the athletes in the competition. The surface of the high jump apron is a very, very thin layer of rubber that is well past its prime. In the area where the athletes plant the foot to leave the ground the rubber is gone (see picture) and the athletes can not get the spiked shoes to hold to assure a safe plant for take off. The apron is developing several cracks in the surface and in needing immediate attention. |

Picture #14 . . . shows what was once a very good high jump apron. The rubber is extremely thin on most of the apron with many cracks starting to appear. The worst area of the apron is the most important part of the apron . . . the take off area. The take off area is now worn to very hard blacktop and it does not give the athletes the ability to properly plan their foot for take off. This area needs immediate attention.

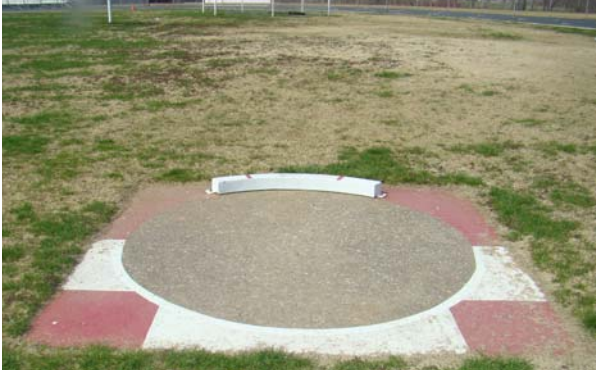
| Shot Put Venue (General Notes) | The biggest problem in the shot put is the grass clippings that are still on the concrete. Grass on the slab with moving athletes can be a safety concern. Consideration should be given to putting in a true shot put sector with the crushed lime stone which will cut down on the number of divots and holes in the all grass sector. |

Picture #15 . . . shows the shot put circle with all the loose grass clippings that need to be removed to assure safe footing for the athletes. It shows the need for a new paint job as well. It shows that sector lines have not been placed on the ground and this should be done for practice as well as competition.

| Sector and Cage | At the time of this inspection no sector lines were on the ground but the proper 34.92 sector marks were placed on top of the toe board. It is recommended that sector lines be on the ground even for practice to help athletes understand where the implements must land. No cage is present and it is not required for shot put competition. |

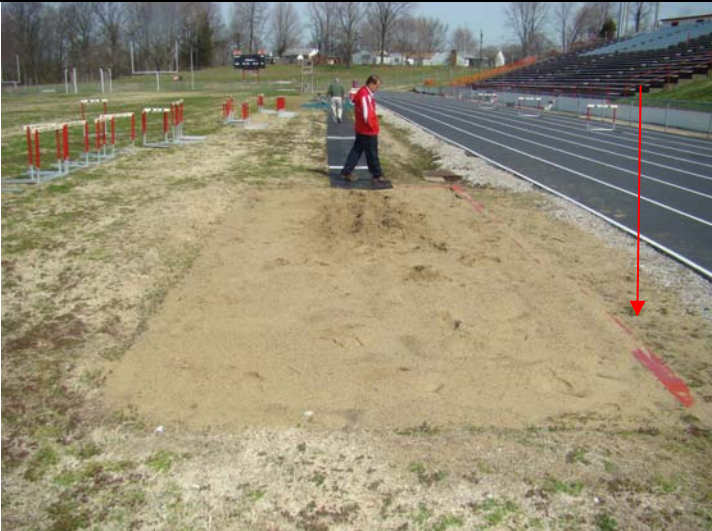
| Sand Pit Condition | At the time of this inspection both pits are unsafe for jumping (see pictures). On the boys pit the wood edging near the track is exposed with very faded paint while on the back and infield side the wood is completely covered with sand. The sand pit is designed to be a safe landing area with its boundary (edges) well marked. With the edges of the Daviess County sand pits basically covered the athletes can not distinguish where a safe landing actually is . . . it is recommended that jumping be discontinued until these safety issues can be addressed. (see pictures). |

Picture #16 . . . this picture shows what is described as the boys long and triple jump pit. The red arrow shows what is supposed to be the edge of the pit and it is supposed to be visible all the way around the pit. When it is not visible it is hiding a potential hazard and that is a liable situation.

Picture 16 and 17 . . . together show the finish straightaway of the track and the possible safety concerns that an athlete would have if they had to step off the track during competition.

The area around the track is not level and because spikes are not recommended on the very hard track surface, the spikeless shoes tend to slip in the gravel and/or down hill slopes.

| Long and Triple Jump Venue (General Notes) | At this time the two sand pits are both unsafe and should not be used for practice and/or competition until all safety issues are addressed. |

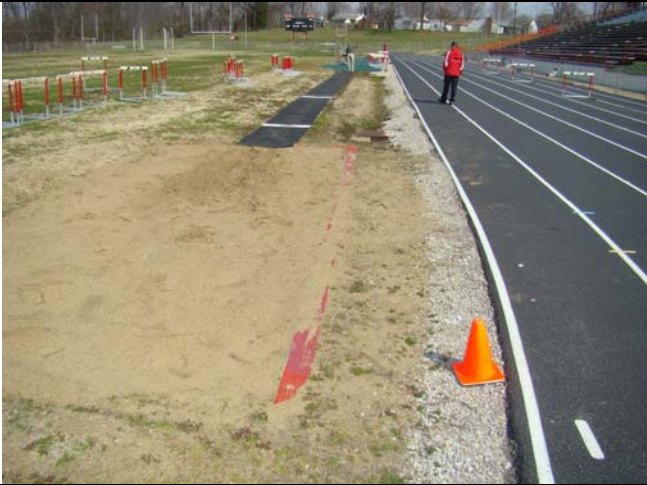
Picture #17 . . . shows the boundry board visible near the track but where is it on the other sides.

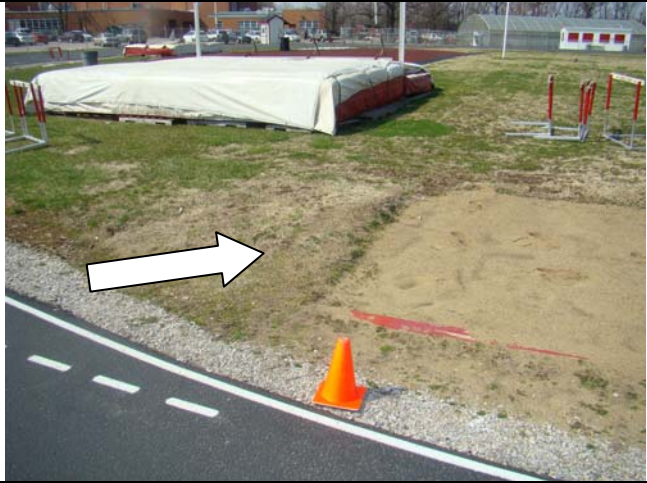
Picture #18 . . . the edges around the pit should all be ground level to help athletes avoid from tripping as they leave the pit.

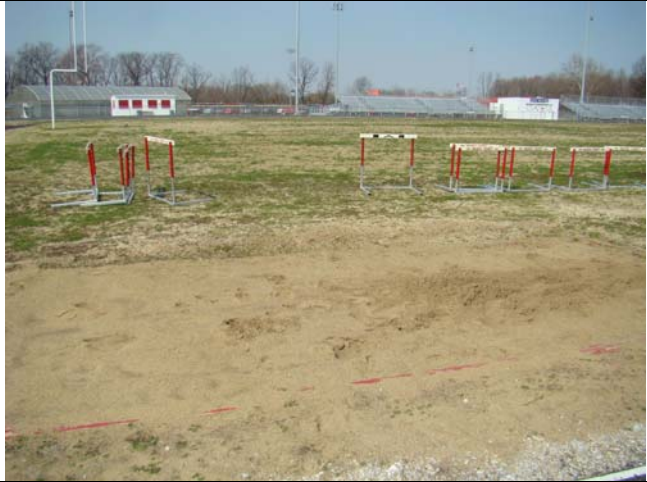
Picture #19 . . . Shows that you can not tell where the pit begins or ends.

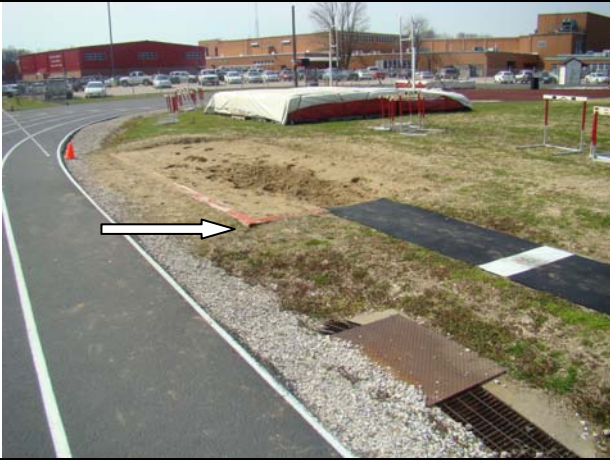
Picture #20 . . . again shows that the boundary lines of the pit are not present all the way around. The boundary lines should be level with the surface around the pit but the slope of the crown on the football field make this difficult.

The arrow points to a sharp corner of the boundary lines that is very much a liable situation.

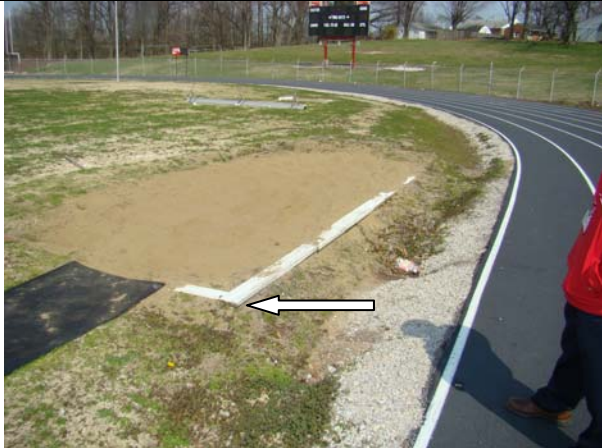
Pictures #21, #22 and #23 show the pit that is designated for the Girls.

The area to the right of the pit is very unsafe with the drop off to a drainag ditch and the down hill gravel, no safe footing .

The arrow points to a very sharp edge that is a liable situation.

Picture 21 and 22 show that the boundary lines of the pit are only visable to the right. Where is a safe landing on the left?

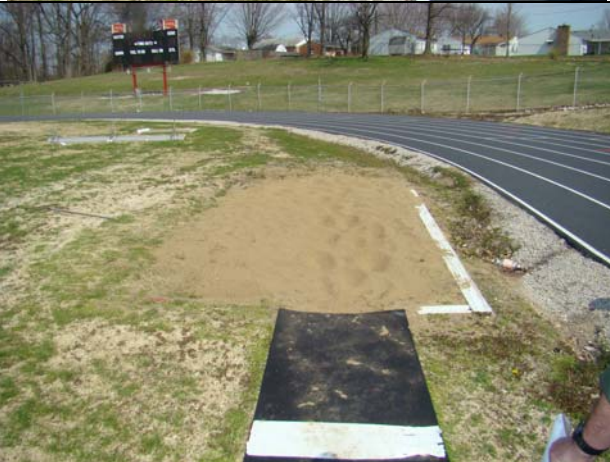
Picture #22 . . . shows that the runway approach is off center. The pit is supposed to be 9' wide but the best measurement we can obtain is 8' and with the runway set more to the right it is a very dangerous pit as the right side is already unsafe.

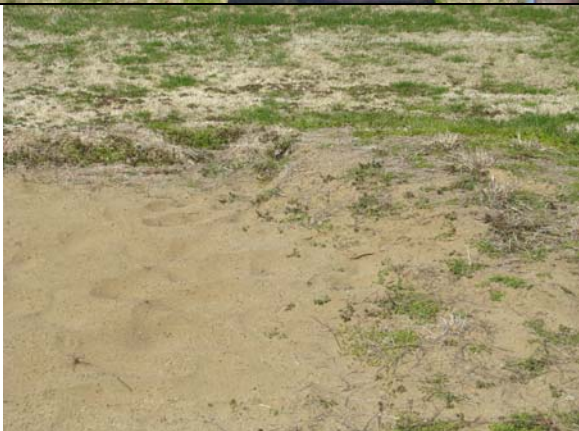
Picture #23 . . .

Where is the Girls Long Jump/Triple Jump Pit in this picture.
