Kentucky High School Athletic Association – Track & Field Site Inspection

LaRue County High School – Owensboro, Kentucky

Date of Inspection: Monday – April 7, 2008

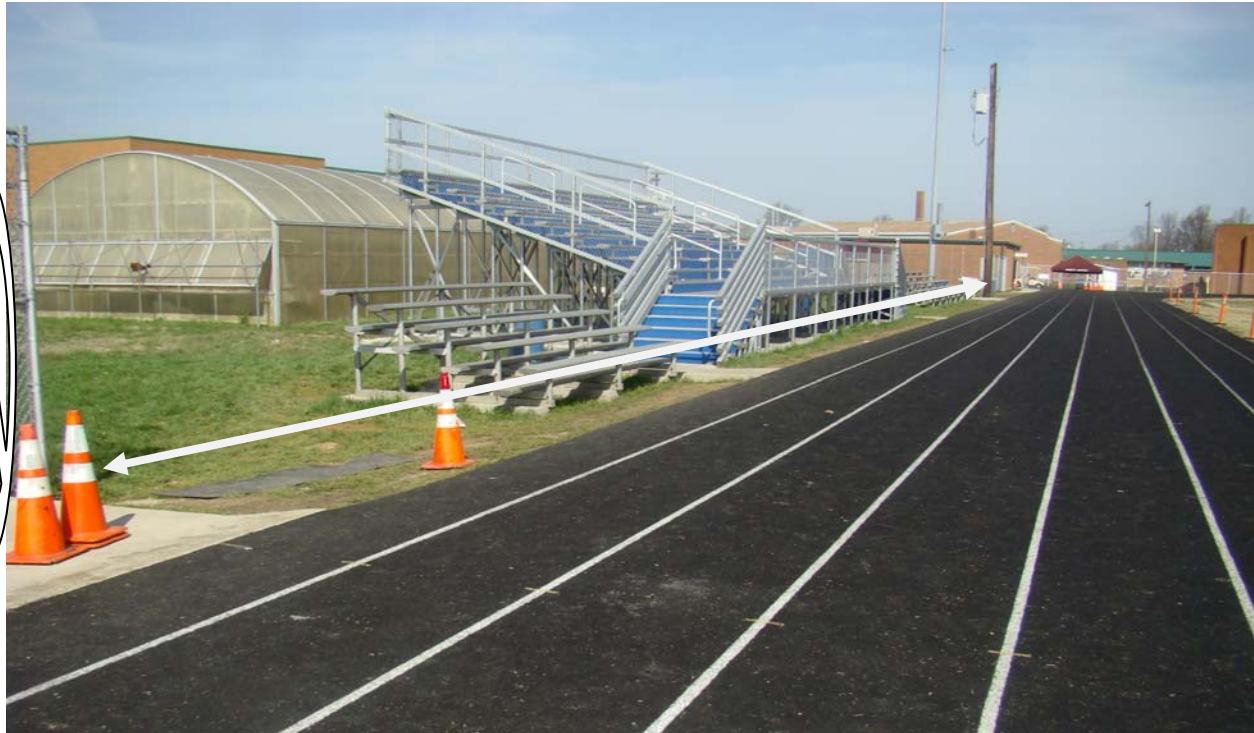
Picture #1

This picture shows the finish straightaway and the concerns that I have with crown control. At a recent invitational the spectators entered jus to the left of the picture by the two cones as well as down near the maroon tent at the end of the straightaway. Either case had fans walking on a track that is there for the athletes and must be kept fee of spectator traffic at all regional competition. Make plans now for better crown control at track meets as this is very much a safety issue.

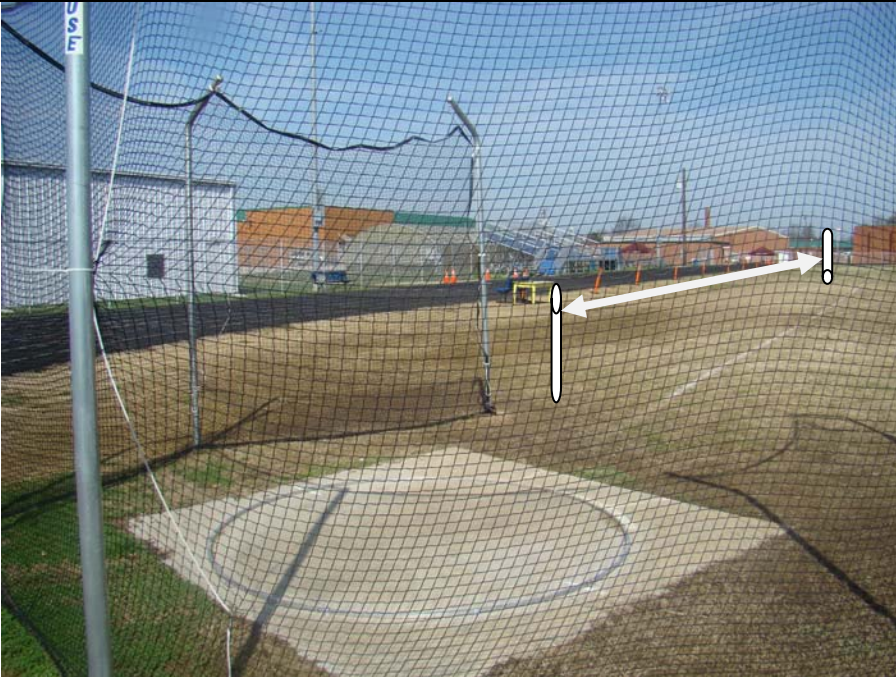
Picture #3

Show how close the discus venue is in relation to the finish line. Some type of flagging needs to be in place to keep finish line personnel and finishing athletes from wandering into the discus sector with flying implements.

Finish Line Safety	The finish line has a very high fence outside of lane 7 and it is back far enough to not be a safety issue. On the infield of the track the finish is very close to the discus area. Flagging will need to be put down the discus sector lines to help remind officials and athletes that a throwing area is near by.
Surrounding area (This could include bleachers, fencing, trees, limbs, etc.)	The only real concern is the crowd control that can be a major issue in a track and field competition. A crowd control plan must be put in place before the Region to assure the safety of the athletes and the spectators.

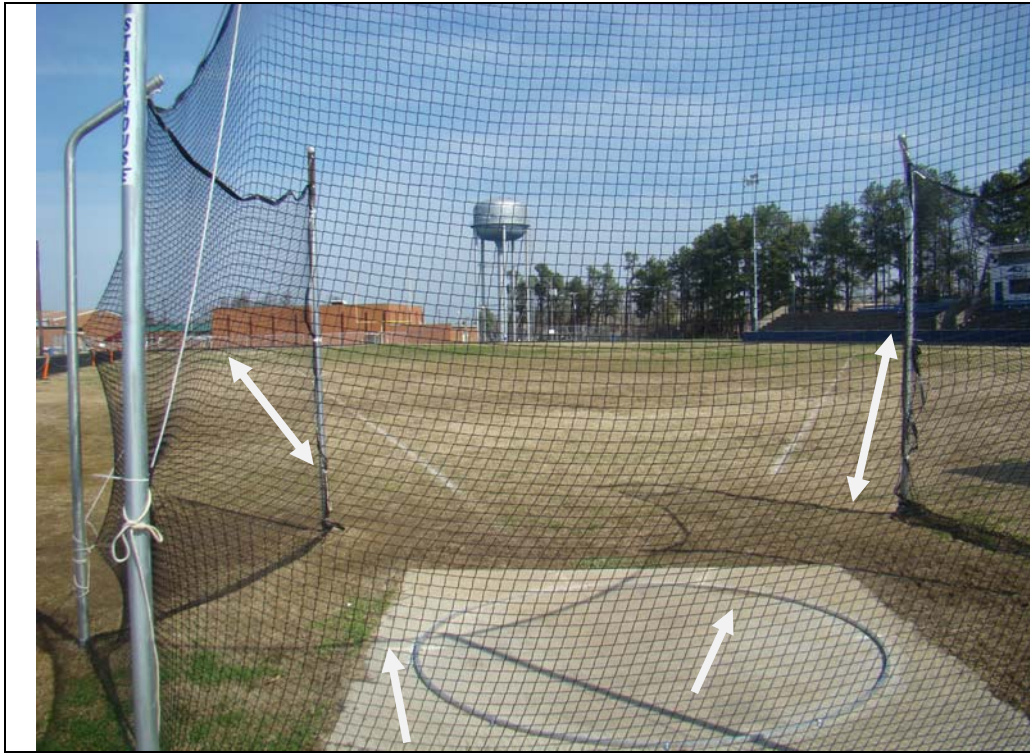
Picture #4

This picture shows the discus throwing sector. The White Lines indicate where flagging needs to go to cut down the chance that anyone will walk into the sector.

The finish area is immediately to the left and the corner of the high jump apron is on the immediate right.

Grass starting to grow on the slab in something that needs to be clipped back and the area kept clean.

Grass clippings in the circle are a safety issue with spinning athletes trying to perform on a slick surface.

Surrounding Area	The discus venue is very close to the finish line on the left and the high jump venue on the right and therefore should be flagged at all times (practice and/or competition) It should be flagged with a highly visible material.
Discus Venue (General Notes)	The biggest problem with this venue is keeping it dry and clean to assure the proper footing of all the athletes. Looking at the picture of the discus venue shows that a problem may exist around the concrete because of wet muddy conditions. Wet and muddy conditions cause problems for athletes in an event where a lot of technique is involved. Grass clippings must be swept out of the circle to assure safe footing.

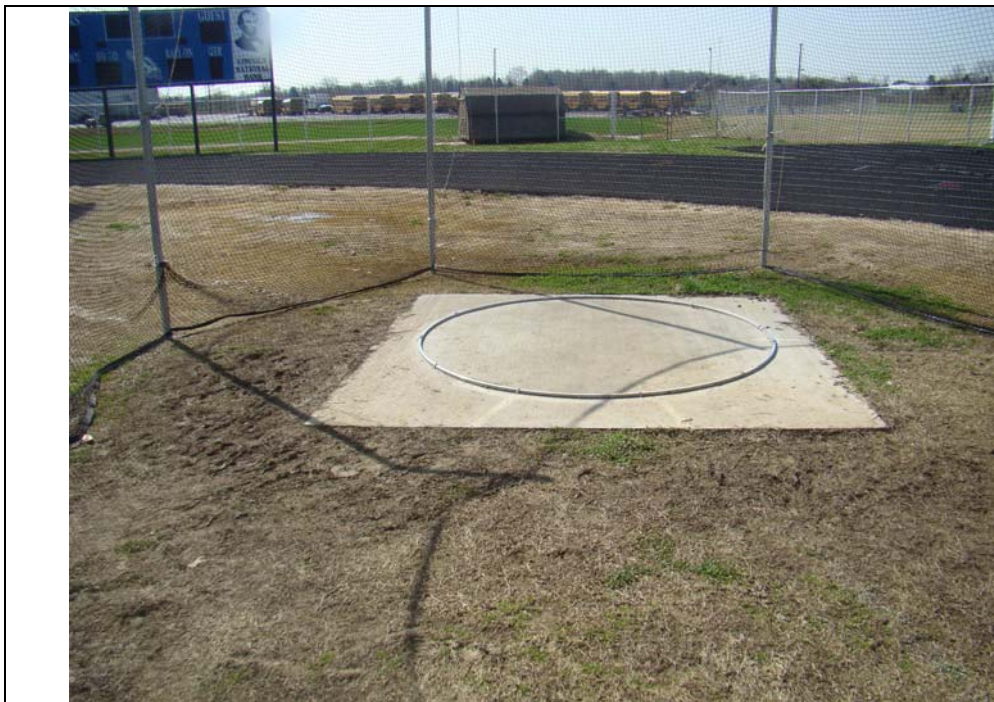
Picture #5

The picture shows the problems with footing with the discus venue. Brooms and/or a blower needs to be present at the Regional and every attempt made to keep the circle and the area around it clean and dry.

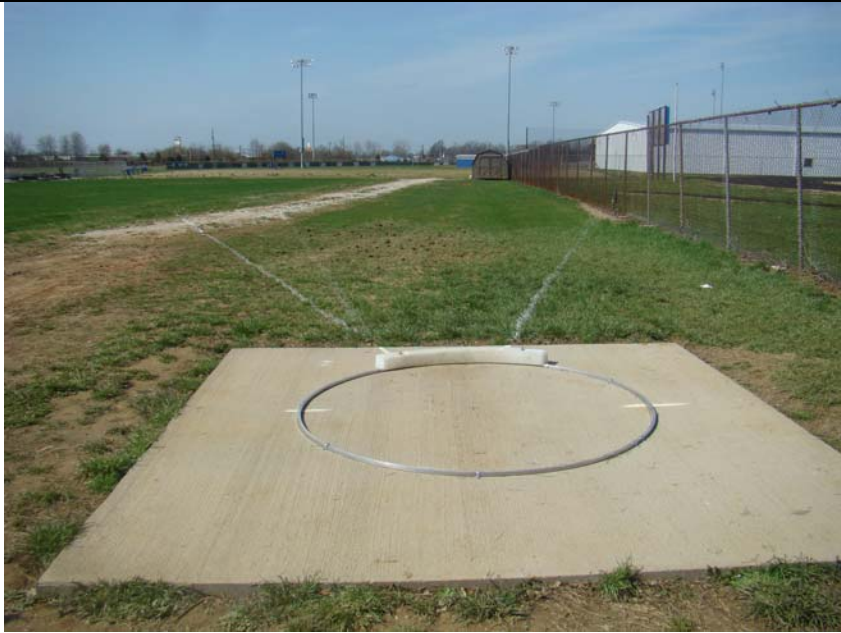
Picture #6

This picture shows the shot put venue and the unlevel conditions with the throwing sector. Rocks, clumps of grass and mud do not make a good throwing sector.

Fill dirt should be placed around the concrete pad to avoid possible slipping as athletes step off the pad.

This area needs a renovation with leveling of the sector and crushed limestone placed inside the sector and grass planted on the outside of the sector.

Would improve the looks of the area with school colors on the front and back half of the pad.

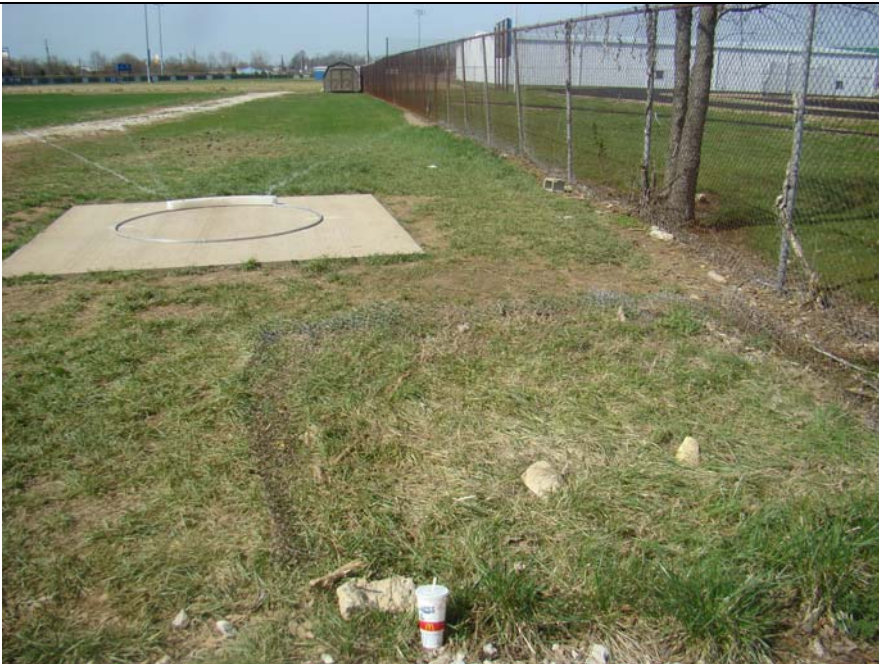
Picture #7

This picture shows the unlevel conditions that exist in the throwing area as well as some safety concerns with large rocks, concrete blocks, half buried chain length fence, trash and high grass.

Surrounding Area	It is pointed out that spectators should not be allowed outside the gate to observe this event. The fence that is between the pole vault venue and the shot put venue is a tremendous safety. The area around the shot put pad needs a general clean up. Old chain link fence just laying around with large rocks in the area is an accident waiting to happen and very much a liability issue. Needs immediate attention.
Shot Put Venue (General Notes)	Has the potential to be an excellent throwing venue Sector needs leveled and a permanent sector put in Liability issues with trash in the area needs immediate attention Painting of the front and back half of the circle in the school colors will dress this area up nicely.

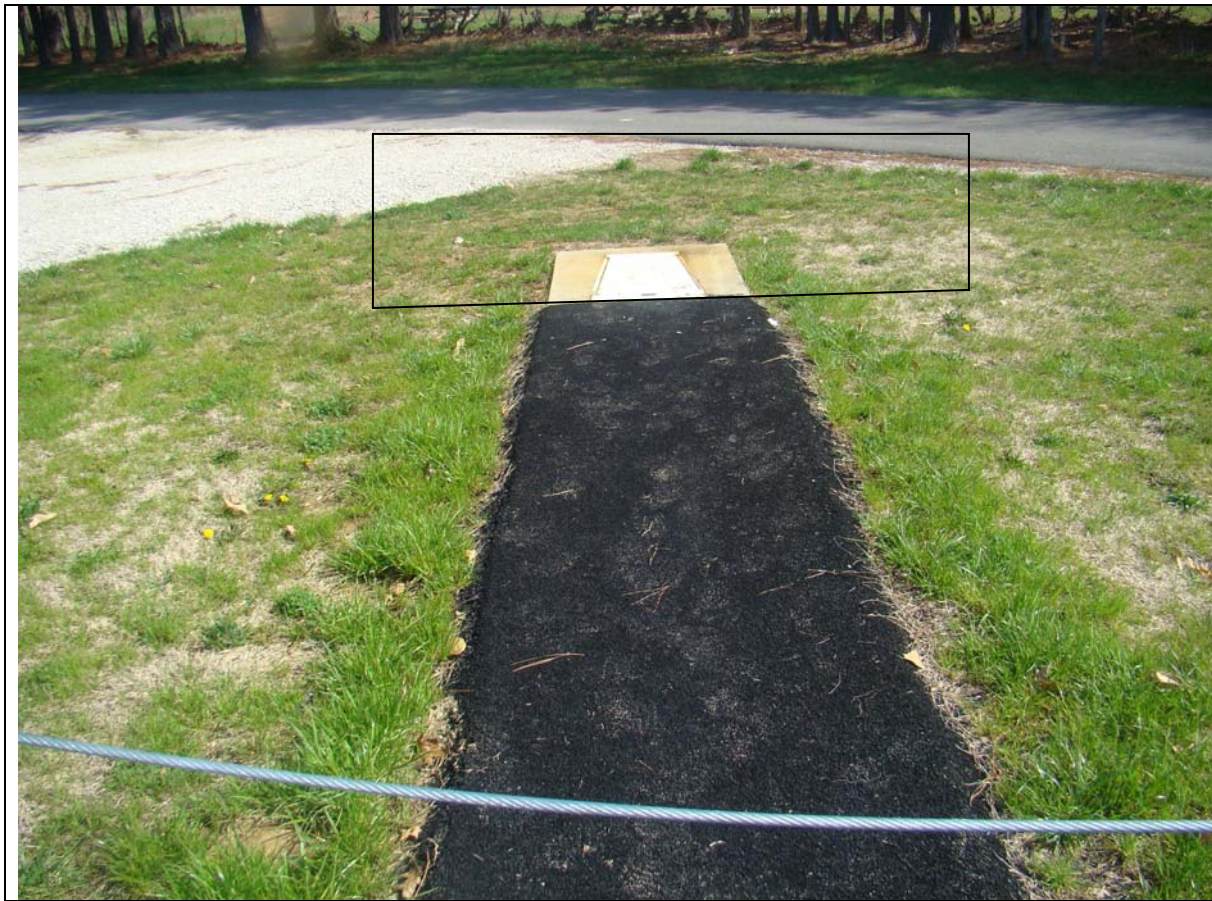
Picture #8

This picture shows all that is present with the current pole vault venue, a runway and a box planted in concrete.

The black lines indicate a rough size of the landing pad that would probably be on both gravel and blacktop.

Area surrounding the Pole Vault Venue	The area around the vaulting venue will be fine as the only hard and unyielding surfaces are will be a small section of the road behind the pit. Care must be taken if the concrete pad is put down to make sure that it is smaller than the vaulting pad that will be used.
Pole Vault Venue (General Notes)	The current Pole Vault Venue has three major that are very much safety concerns. Issue # 1 With the current location of the concrete runway and vaulting box that is set in this concrete a landing pad that meets all the National Federation Safety requirements has a good portion of the pad sitting on a service road that is used by school buses and other assorted traffic. This is very much a safety issue and the pad needs to be moved back to assure that a safe landing is available. With the current location NF Rule 7-4-4 pointed out. . . . Rule 7-4-4: Hard and unyielding surfaces, such as but not limited to concrete, wood or asphalt, that extend out from beneath the sides and back of the high jump landing pad shall be padded with a minimum of 2-inch dense form or other suitable material. This means that the service road would have to be padded for both practice and competition. Issue # 2 The drainage ditch that is adjacent to the service road would have the landing pad sitting at various angles and could well be a safety issue in regard to a safe landing of the airborne athletes. Another issue would be that of the pit blocking the normal drainage of the area and the possibility of standing water at various times as well as the moving and/or standing water causing undue damage to the underside of the landing pads. Issue # 3 It is recommended that a concrete pad be put in place to put the landing pad on to assure a safe surface and that it be moved back so that the pad is not sitting on the service road and so the natural drainage of the area would not be disturbed. A reminder that this pad would then make it possible to mark the point zero and to have an area that would allow for the Standards to be secured to the ground as is now required by the National Federation. A vaulting box cover needs to be obtained, zero point painted on the new concrete pad, standards secured and the box painted.

Concrete would need to be put in place to provide a method of securing the standards and to eliminate the drainage under the pad that would destroy the bottom of an expensive investment.

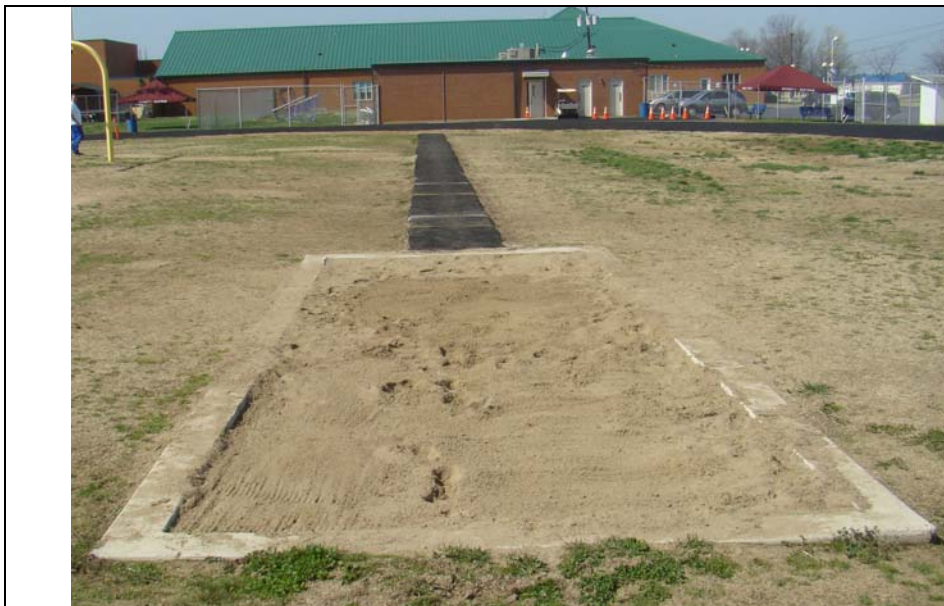
Picture #9

This picture shows the long and triple jump venue. The concrete edges that outline the sand pit are an excellent marker when they are visible. With sand covering the vast majority of the concrete surface the concrete surface has this a very liable area. When the concrete is covered it becomes an unseen hazard.

The sand is to be level with the edges of the pit and the picture shows that it is a little low in most areas.

Long and Triple Jump Venue	Needs more sand added to the pit and the sand swept back into the pit from the concrete and fresh paint on the lines.
----------------------------	---
